Manhole Inspection Summary

Manhole # S63Q__009MH

Location Address: **5600 BLOCK CARDIFF AVE.**

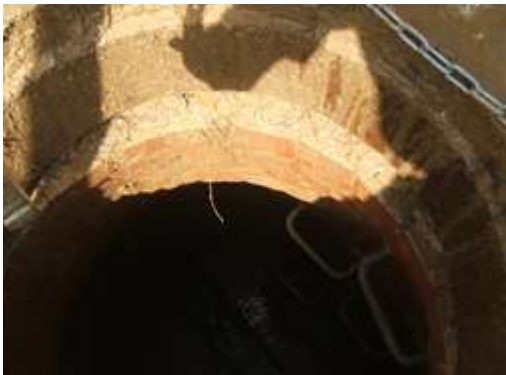
Defect 1

Frame Offset: **2** (in.) Condition: ☒ Sound ☐ Cracked ☐ Leaks

OFFSET FRAME 2"

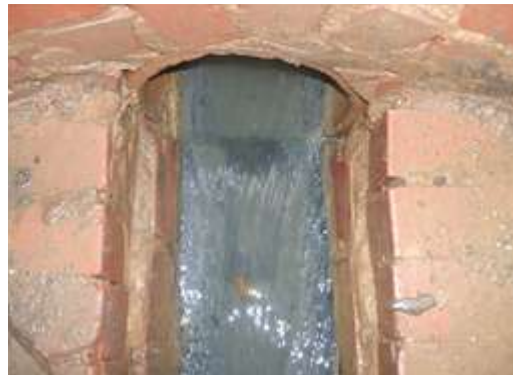
Defect 2

CRACKED PIPE SEAL I6

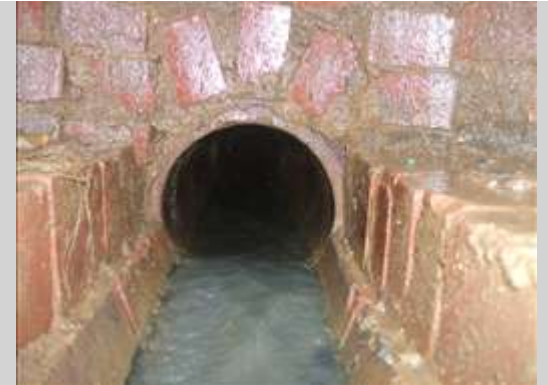
12 O'Clock Outflow

8 in. Circular Gravity Sewer
Pipe Out @ 12 O'Clock

Invert Depth: **8.51** (ft.) Flow Characteristics: **Slow**

Infiltration: **None** Pipe Seal Cond: **Sound**

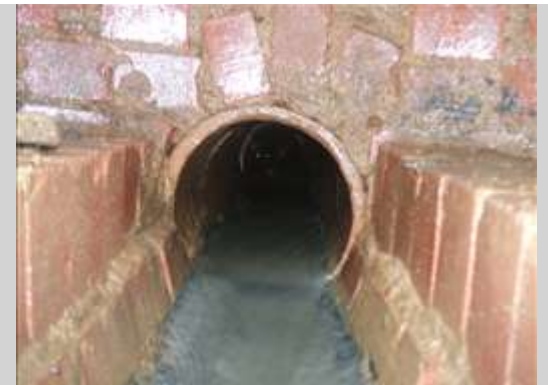
6 O'Clock Inflow

8 in. Circular Gravity Sewer
Pipe In @ 6 O'Clock

Invert Depth: **8.50** (ft.) Flow Characteristics: **Slow**

Infiltration: **Evidence** Pipe Seal Cond: **Cracked**
